# FIRE TEST REPORT

CAN/ULC S134, STANDARD METHOD OF FIRE TESTS OF EXTERIOR WALL ASSEMBLIES  
CONTAINING PANNEAUX 3D ACM PANELS WITH 4 MM FR BY STACBOND

103816489SAT-003

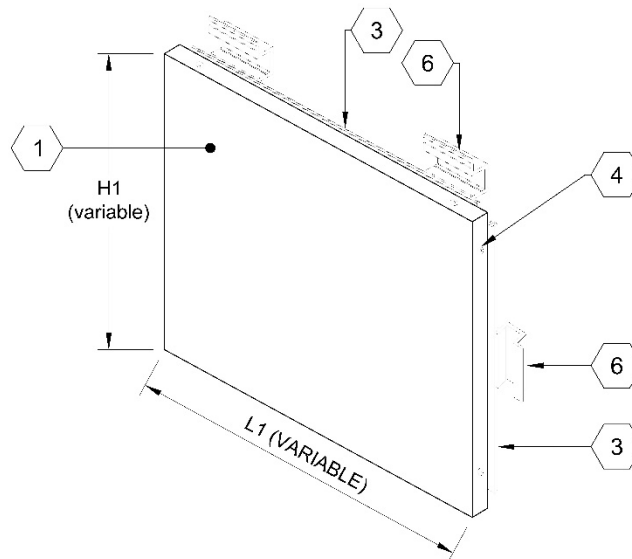
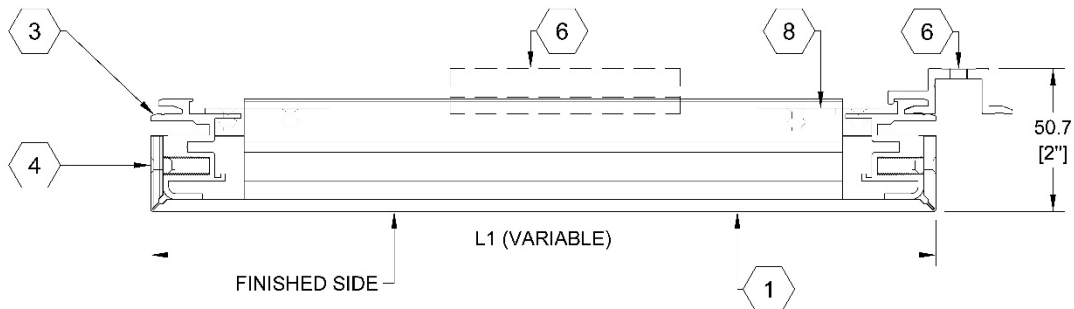
### FUTURA FC-100

#### ISOMETRIC VIEW (TYPE "SA")

#### COUPE A (CROSS SECTION)
